SAFETY BULLETIN

No. 2009-07

SUBJECTS: Miller Back Biter lanyards

Backbiter rivet issue

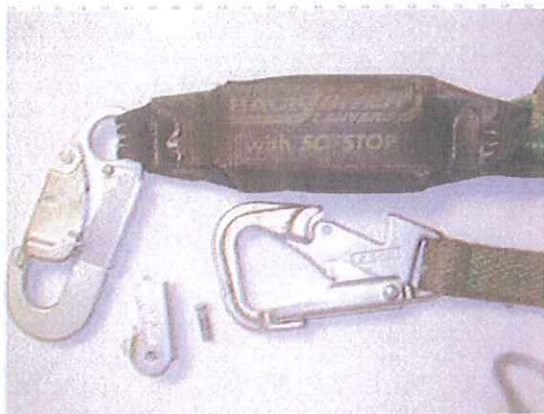
Miller Back Biter lanyard being used by employee at time of failure. Date of manufacturer of this particular lanyard is 05/09/08. In service date of this lanyard was 02/17/09.

Action Needed: There was an identical incident in October of 2008 at another facility (same manufacturer, same model and same failure). If you are currently using Miller Back Biter lanyards (either single or double legged), an immediate inspection by a competent person is needed. If there is any question to the integrity of a lanyard, remove it from service and contact your supervisor or a contractor safety professional on a path forward. Additionally, your company should evaluate whether to continue to utilize this lanyard.

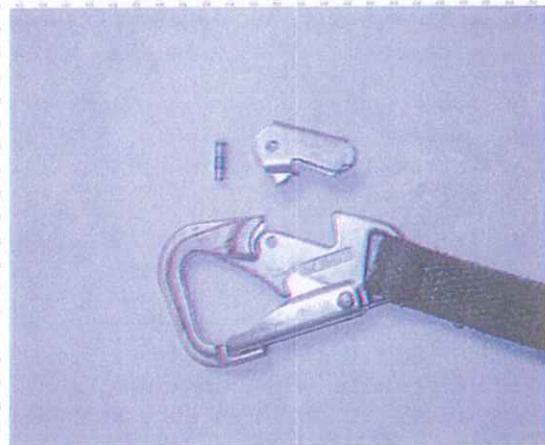
The detached locking keeper and the rivet that held the keeper in place. Upon inspection, neither appear to show signs of damage or abuse. The head of the rivet appears to be cleanly sheared off.

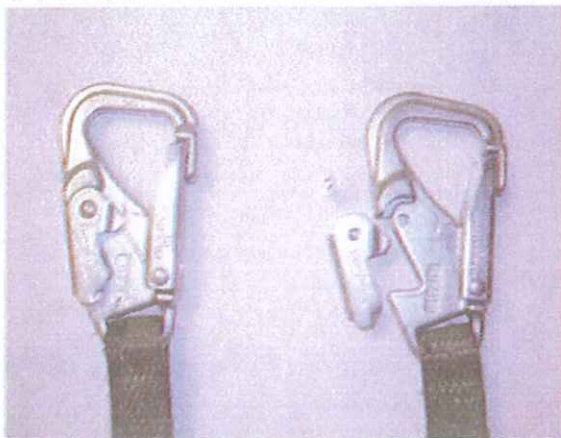
Side by side comparison of the two snap hooks on the lanyard that failed. Neither snap hook appears to show any signs of damage or abuse. A better look at the clean shear of the rivet holding the locking keeper to the snap hook.

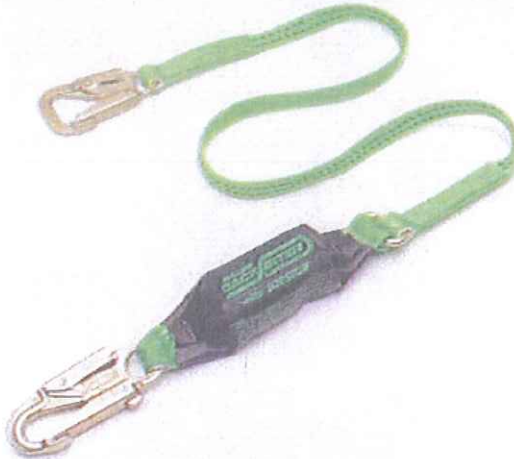
Background: We were notified of a backbiter rivet shearing, causing the keeper on the snap hook to detach from the unit. Note: The snap hook and gate were still intact. With the keeper becoming unattached, this resulted in the loss of dual-action functionality of the snap hook. The lanyard and snap hook were drop tested at our facility and passed all applicable ANSI testing. Rivet was analyzed and was to specification metallurgically.

Corrective action: A letter was published to our customers explaining the situation. We were not able to duplicate the failure in our test lab. From the analysis we performed, we concluded that the rivet pin, if repeatedly struck, drug across rough surfaces, and abused, could possibly cause the rivet pin to shear. (We had no test data to prove, but we did have two instances in the field). We instructed our customers to carefully inspect the rivet heads for signs of wear prior to use.
