## PRODUCT ADVISORY

### **BREAKAGE OF CARABINER PINS IN NORTH SAFETY PRODUCTS SAF-T-GRIP SLEEVES**

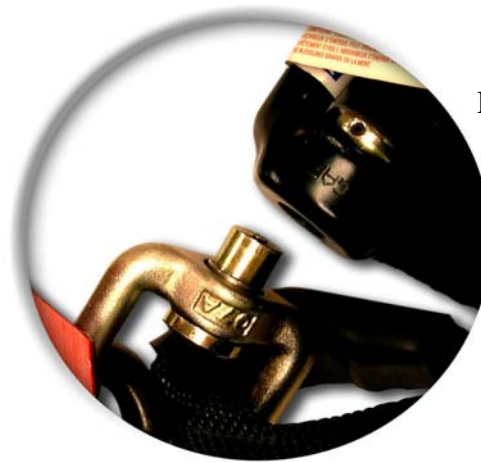
Diagram A:

North Safety has received reports that the pin attaching the carabiner to the Saf-T-Grip sleeve has occasionally broken in ordinary use. The pin is shown in Diagram A.

The pin in the carabiner assembly is part of an energy management system engineered into the Saf-T-Grip sleeve for safety purposes. It is *intended* to break if a fall occurs, permitting deployment of the force-limiting energy absorber that is attached at one end to the carabiner and at the other end to the D-ring on the sleeve. The energy management system engineered into the Saf-T-Grip sleeve will reduce deceleration forces on the user's body when the sleeve arrests a fall and, by reducing those forces, will reduce the severity of injuries they might otherwise cause.

**Breakage of the pin will not prevent the Saf-T-Grip sleeve from arresting a fall.** It does, however, prevent normal use of the system. *Users must be clearly instructed that, if such an event occurs, they should not detach their safety harness from the carabiner unless they are near the ground or in some other safe location.* If they detach their harness from the carabiner they will be without any fall protection and could be injured or killed in a fall. A user who experiences such an occurrence should instead descend the ladder using the following method:

North Safety is conducting its own evaluation and testing to identify the root cause of the pin breakage and how to prevent it in the future. North Safety believes pin breakage is caused by cyclic loading that results from unusually frequent engagement of the sleeve with the rail. One cause for frequent engagement of the sleeve with the rail is users' attempts to climb too fast. Another is use of the Saf-T-Grip sleeve with a safety harness that is not equipped with an attaching D-ring near the level of the user's navel. Engagement of the sleeve with the rail should occur only infrequently if proper climbing technique is used as described in the training DVD and in the instructional manual. North Safety has also learned some users may be misusing the system to suspend themselves. To reduce the likelihood of pin breakage until North Safety has identified a permanent remedy for the problem, users are strongly encouraged to use the system as described in the instructional manual and as illustrated in the photographs and DVD that accompany this Advisory. Users should be told that:
